Report No: FO000281

Client	Petronas Energy Canada Ltd.	Inspection Date	Jan 7, 2018		
Prov. Reg. #	AB 0586440 BC BPV-048529	Inspection Type	VE / UT / PSV		
Equipment Type	Glycol Contactor	Location	Town		
Tag/Equip.		LSD	BC A-058-H/094-B-16		
Status	Not in Service	Downhole LSD			
Manufacturer	Propak Systems Ltd.	Area	Town		
Serial Number	081926-101	Year Built	2008		
CRN #	T6576.21	Service	Sour		
Comp/Unit Id	Dehy #3	Manway	None		
Nat.Board #		Coating	Unknown		
Interim Insp'n		Interim Type			
Next Thorough Insp	9999	Next Insp Type	VE / UT		
Length		Height			
Volume	Capacity	Client Reference	1005234		
Owner	Petronas Energy Canada Ltd.	RT	1	HT	YES
Foreman	SBU	RAE Job No.	6882		
ABSA	Plant: H Vessel: P Process: W Special: B		ASME	Sec. VIII div. 1	
History Log	AB-10 - internal entry - LSD changed - entered August 27, 2015. PSV Service Report - dated July 18, 2017

A visual external inspection was performed at this time.

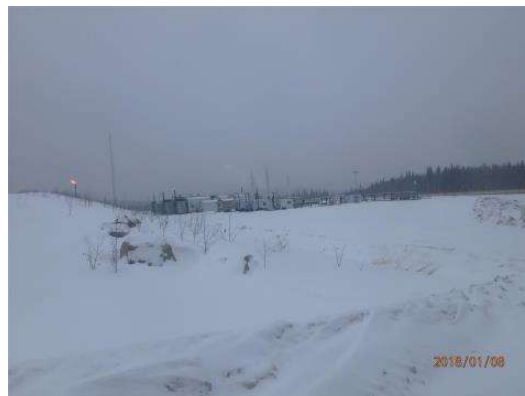
Figure: 2

Site Overview

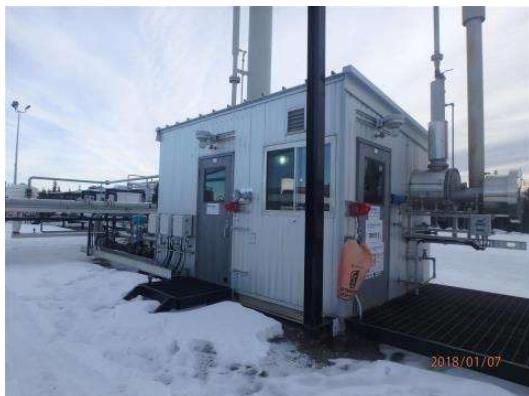
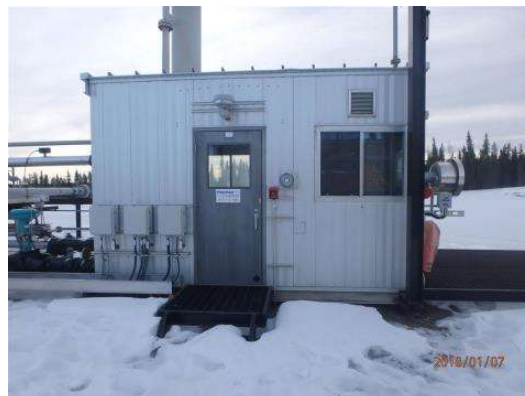
The building was generally in good condition, well lit, and adequately supported. The checker plate steel floor was clean and in good condition. The doors and windows functioned well and were in good condition. The cladding was generally in good condition with a few small dents throughout. There were no combustibles in the building. There was generally good access to the equipment in the building. The building structure was level. The ground wire was securely attached to the building structure. The building was supported by pilings.

Building Overview

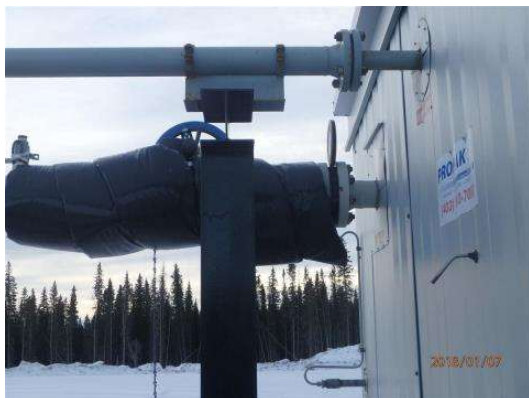
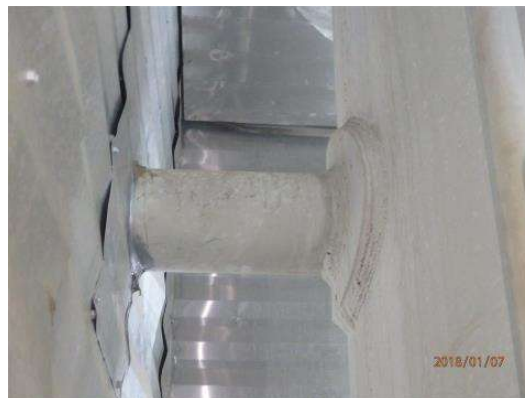
The inlet and outlet piping was painted and generally in good serviceable condition. The piping had welded joints and flanged connections that showed no signs of leakage. The pipe flanges and bolting appeared to be in good condition. The flanged connections were fully bolted.

Inlet Piping

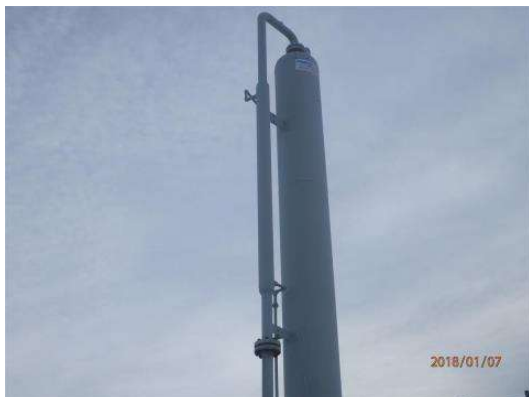
Figure: 7

Outlet Piping

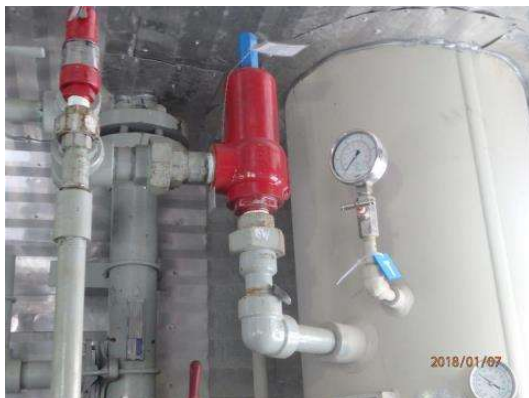
Figure: 8

The PSV was located on associated piping within the building. The PSV was mounted in the vertical position, securely attached to the piping, and in good condition. The nameplate was securely attached and legible. The set pressure was acceptable for the vessel. The service tag was securely attached. The PSV seal wire was attached and intact. The vent size was adequate and vent lines were positioned safely. The outlet piping provided positive drainage for the PSV. The valve on the discharge piping was tagged do not operate and had a seal wire on it.

PSV Overview

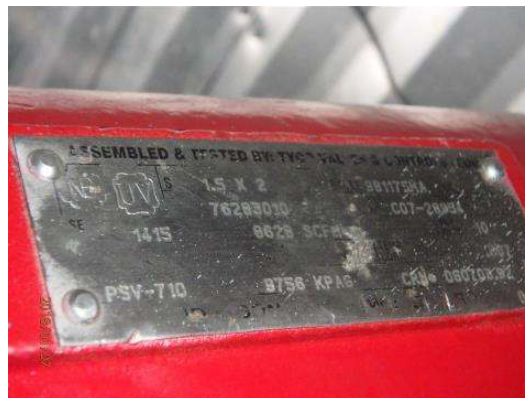
Figure: 9

PSV Nameplate

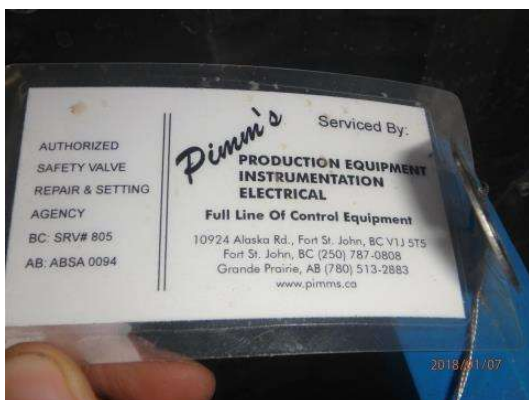
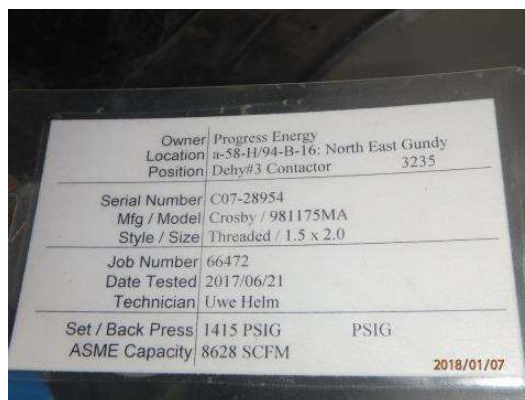
PSV service tag

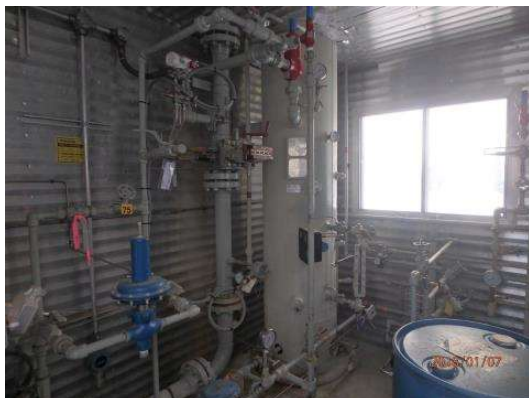
Figure: 12

The bottom half of the vessel was inside the building structure and the top half was located outside the building structure. The nameplate was legible and securely mounted to the vessel. The vessel was identified per serial number stamped on the nameplate of the vessel. The heads, shell, nozzles and bolting appeared to be in good condition with no stress evident on piping or nozzle connections. There was no damage or distortion evident on the vessel surface. The vessel was not insulated it was painted and generally in good condition. The gauges were in good condition. The vessel was vertical and mounted on a skirt that was bolted to the floor. The vessel was adequately supported. The through roof seal was intact and in fair condition.

Vessel Overview (Bottom)

Based on the inspection performed at this time the vessel appears fit for service.

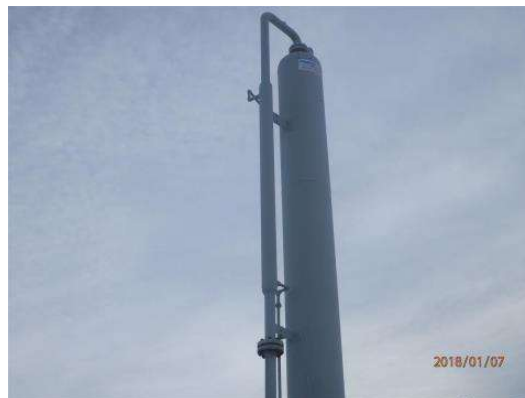
Figure: 13

Vessel Overview (Top)

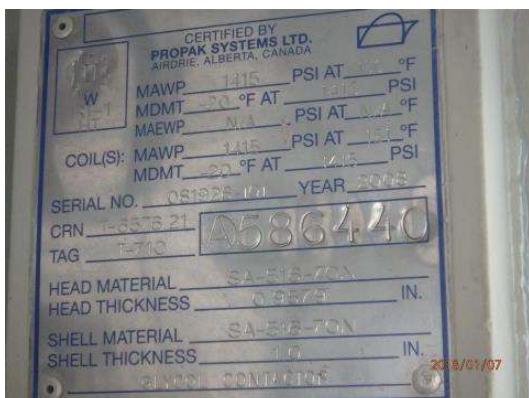
Figure: 14

Vessel Nameplate

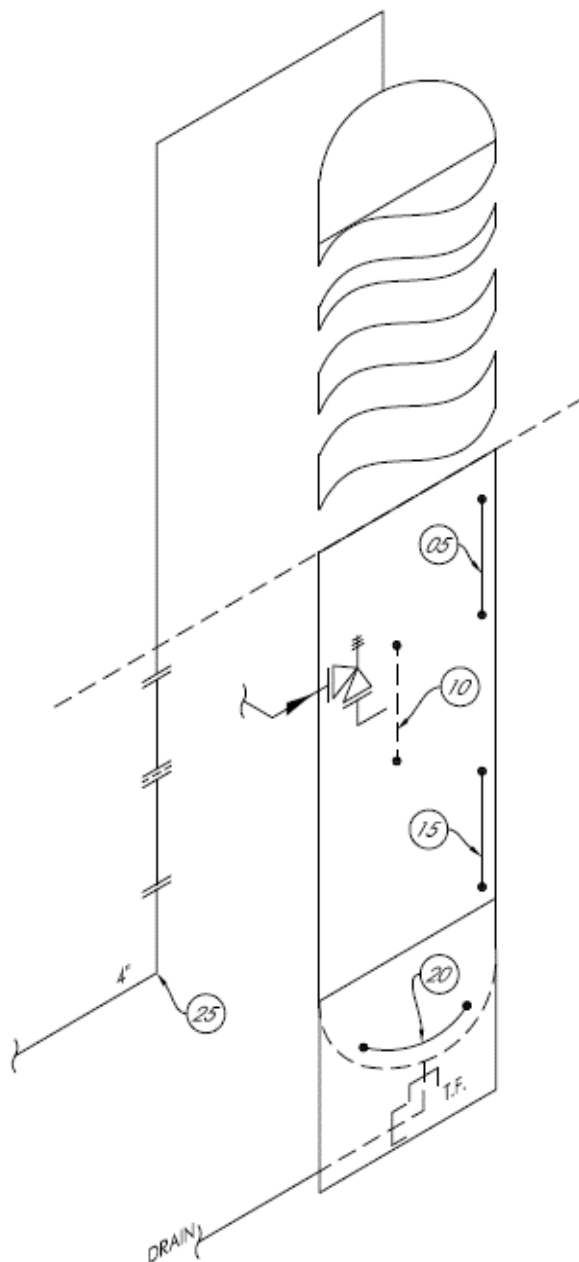
ISO Drawing of Equipment and TMLs

Results: The measurements obtained from the inspection locations show the thickness of all of the components inspected to be at or around nominal. There were no signs of wall thinning, internal corrosion, erosion, laminations or inclusions at the time of inspection.
